# Cultural Resources Reconnaissance Satilla Industrial Park GRAD Certification

**Coffee County, Georgia**

March 2026

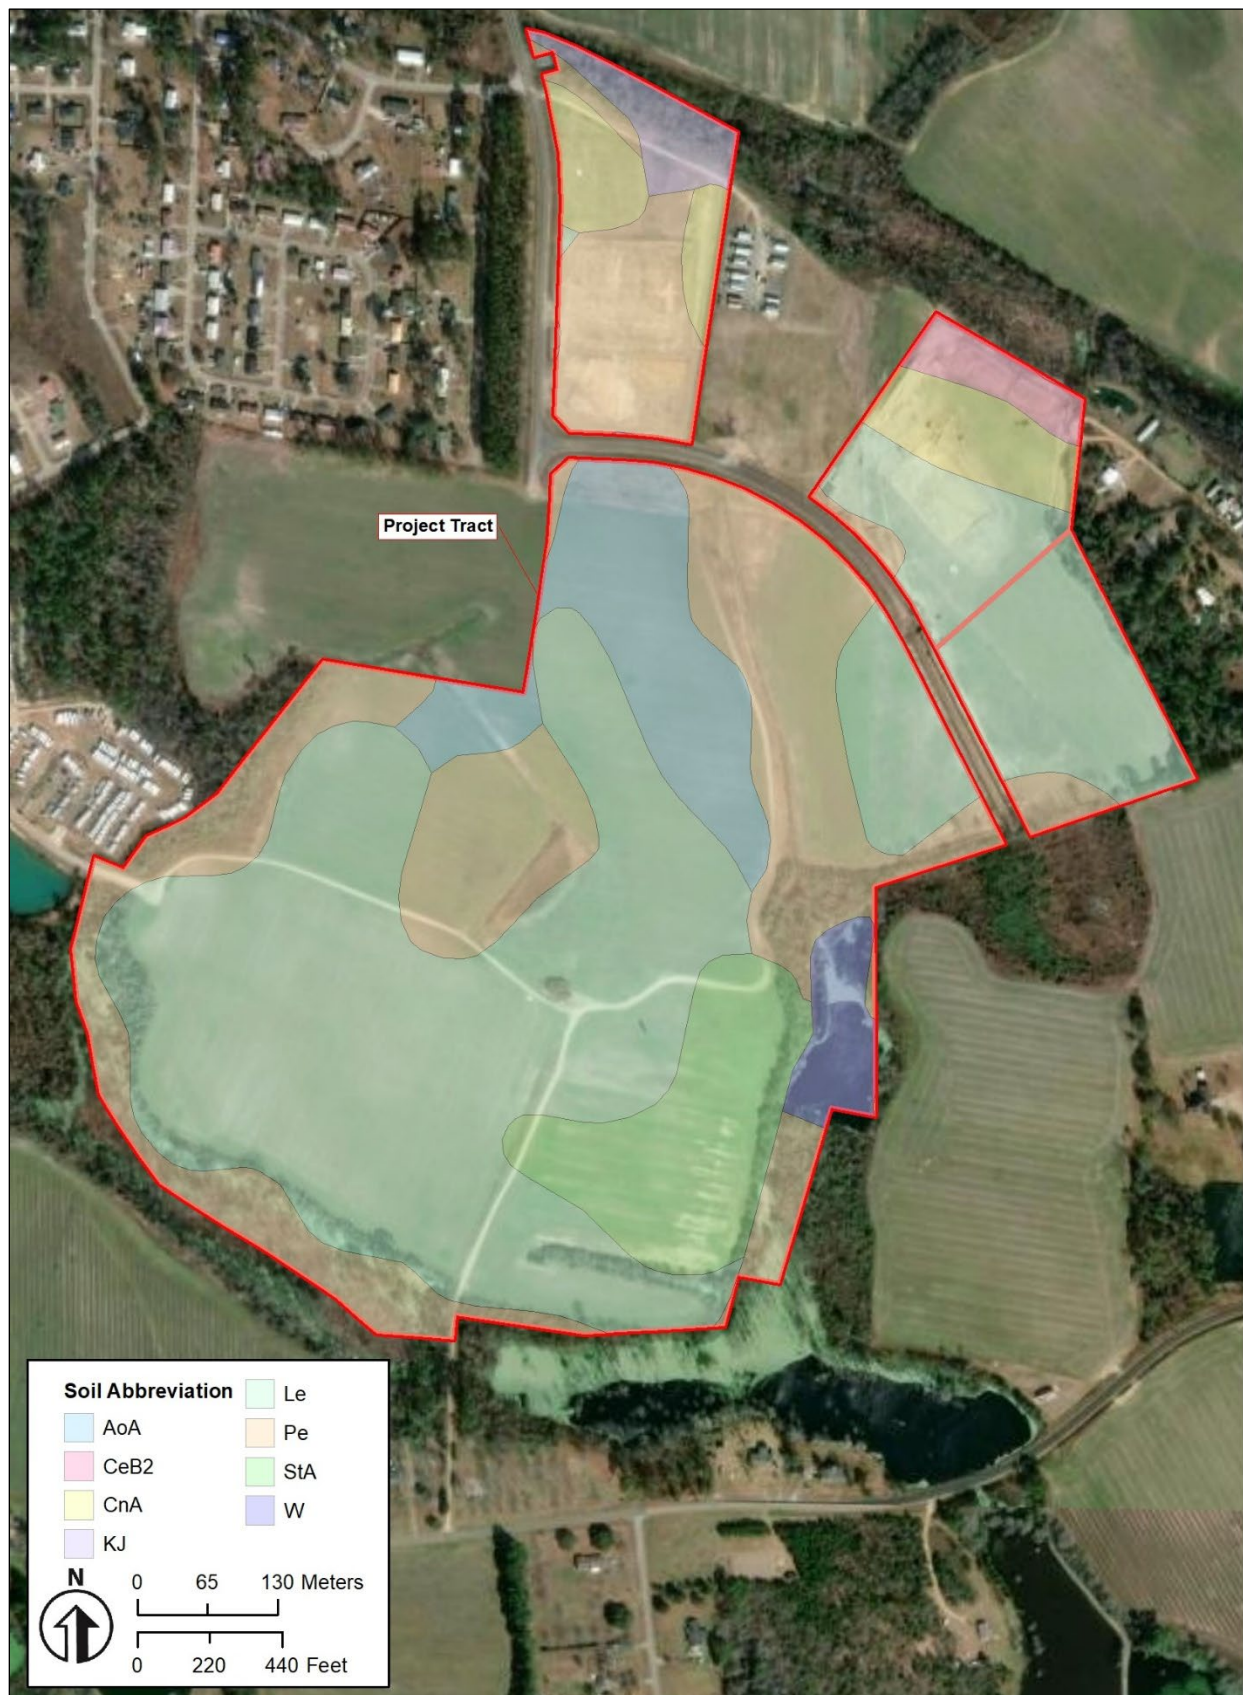
Figure 2.2 USDA soils within the project tract.

An examination of the United States Department of Agriculture (USDA 2026) soils survey identified seven soil types and water within the project tract. Table 2.3 briefly summarizes these soil types, and Figure 2.2 shows their distribution within the project tract. Leefield loamy sand is the most common soil type, covering approximately 48.0 percent of the project tract. A majority of the project tract (84.8 percent) contains soil types that are described as somewhat poorly drained or poorly drained. Moderately well-drained and well-drained soils only cover approximately 13.2 percent (18.9 acres) of the project tract.

Past settlements and agricultural use tend to favor anhydric (dry) soils more than hydric (wet) soils on fairly level terrain; therefore, most archaeological sites tend to be situated on drier, anhydric soils in flat to gently sloping areas. An examination of the recorded soil types indicates that the majority of the project tract (approximately 84.8 percent) has soils that are not favorable to contain an archaeological site.

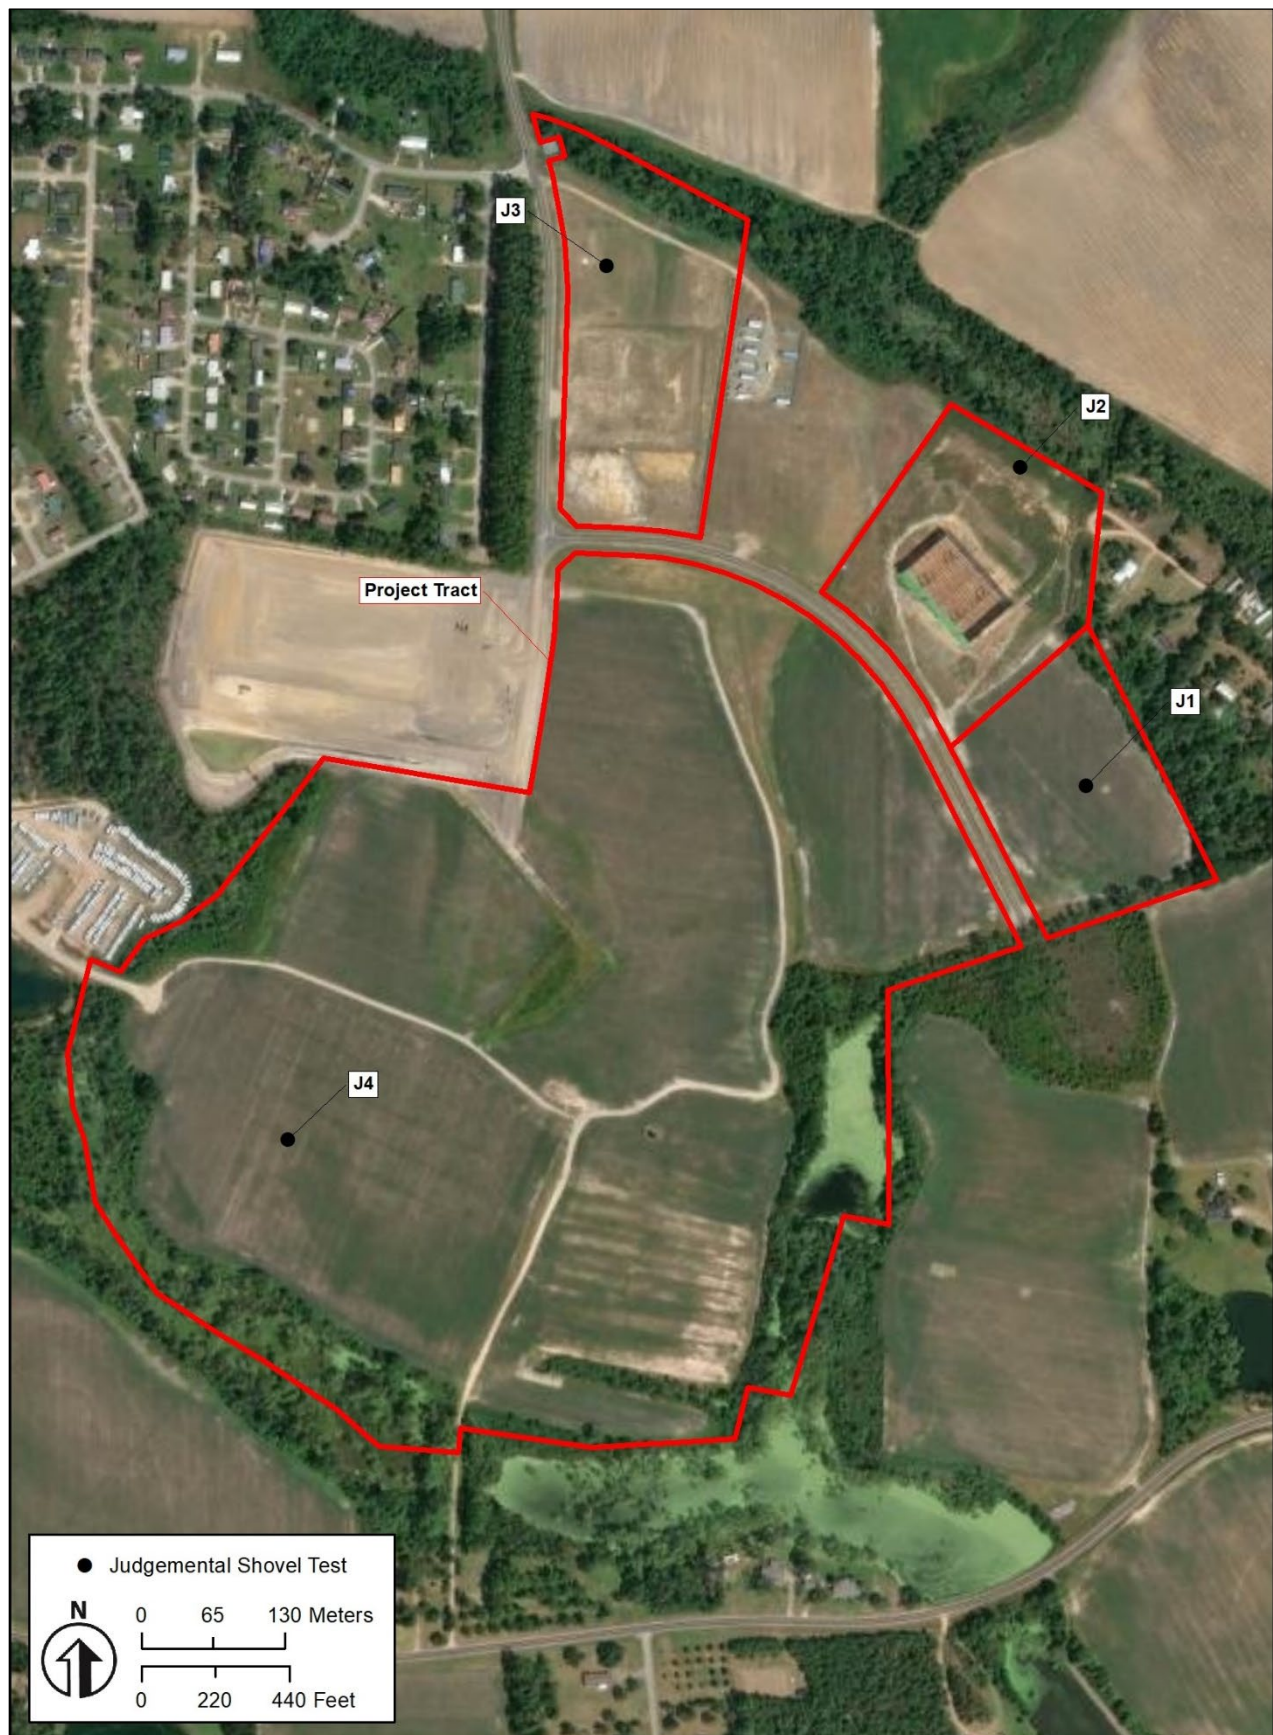
Figure 3.1 Location of judgmentally placed shovel tests within the project tract.

Four judgmentally placed shovel tests were excavated within portions of the project tract located outside of 9CF318. Most of these excavated shovel tests contained soil profiles that are typical of Coastal Plain soils on slightly upland areas in southeastern Georgia. The shovel test consisted of light brownish-gray sand that extended to 10 cm below ground surface (cmbgs), underlain by a brownish gray loamy sand that extended to 40 cmbgs. A brownish yellow sandy subsoil was encountered below 40 cmbgs. One shovel test exhibited disturbance in the northern portion of the project tract as mottled red, gray, reddish brown, and brown sandy clays were encountered below the surface. Figure 3.1 shows the location of the judgmentally placed shovel tests within the project tract.

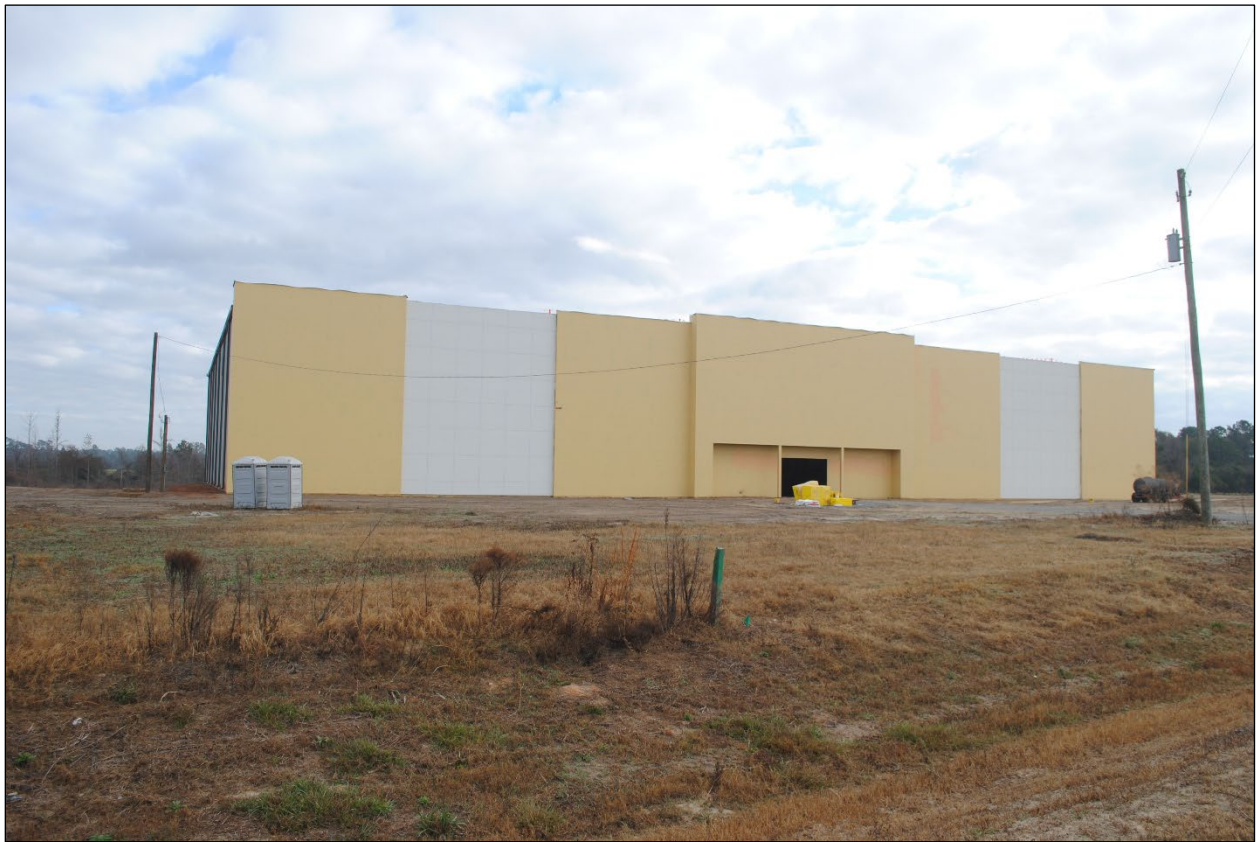
Figure 3.6 View of disturbed area and newly constructed building, facing east.

Our field reconnaissance observed that the project tract is primarily located within abandoned and fallow former cotton fields located along an upland terrace and ridgetop above several unnamed drainages of the Satilla River. Northern portions of the project tract are disturbed with grading and filled soils. An industrial warehouse building has been constructed in the northern portion of the project tract with filled soils. Another area in the northern portion of the tract contains a filled, graded, and leveled terrace which may have been constructed for a foundation location for a future building construction. Other observed disturbances include buried utilities, powerline poles, and dirt roads. Figures 3.2 through 3.9 show typical views within the project tract.

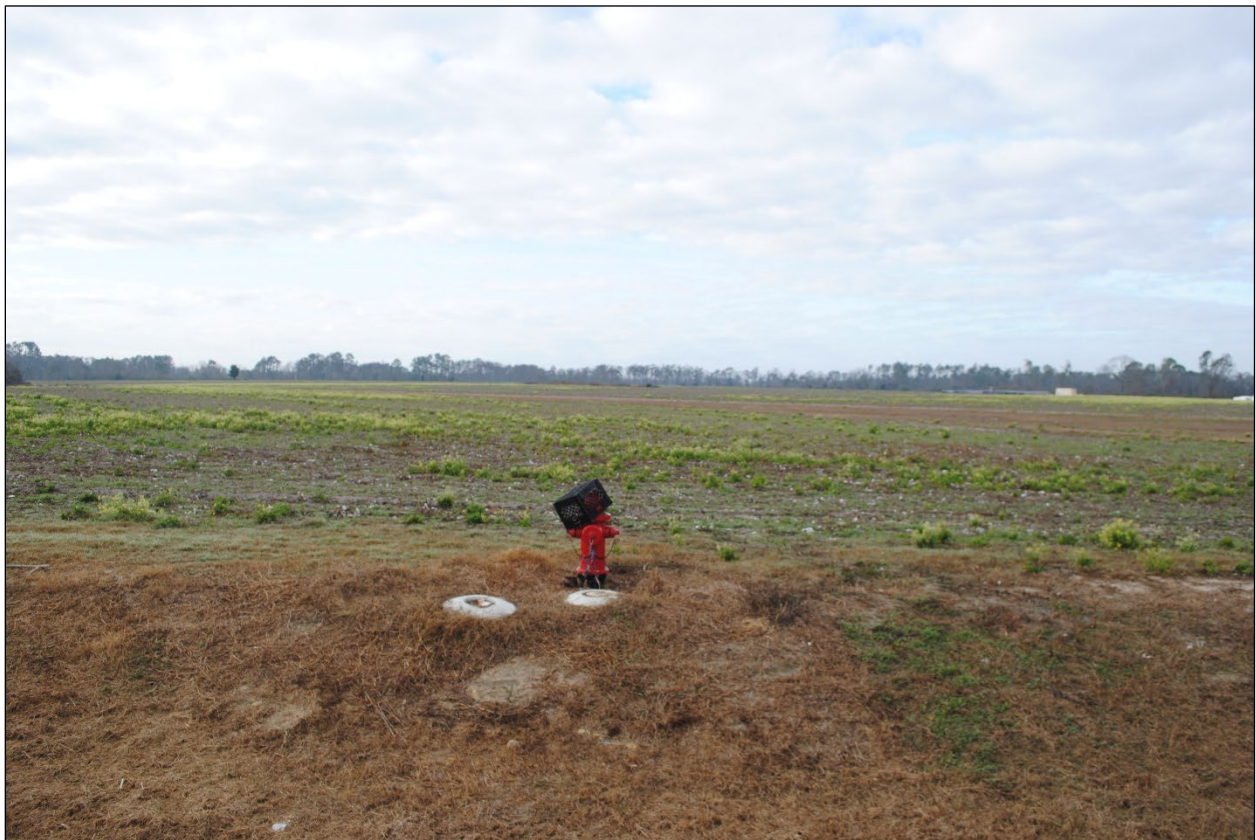
Figure 3.7 View of project tract and buried waterline, facing southwest.

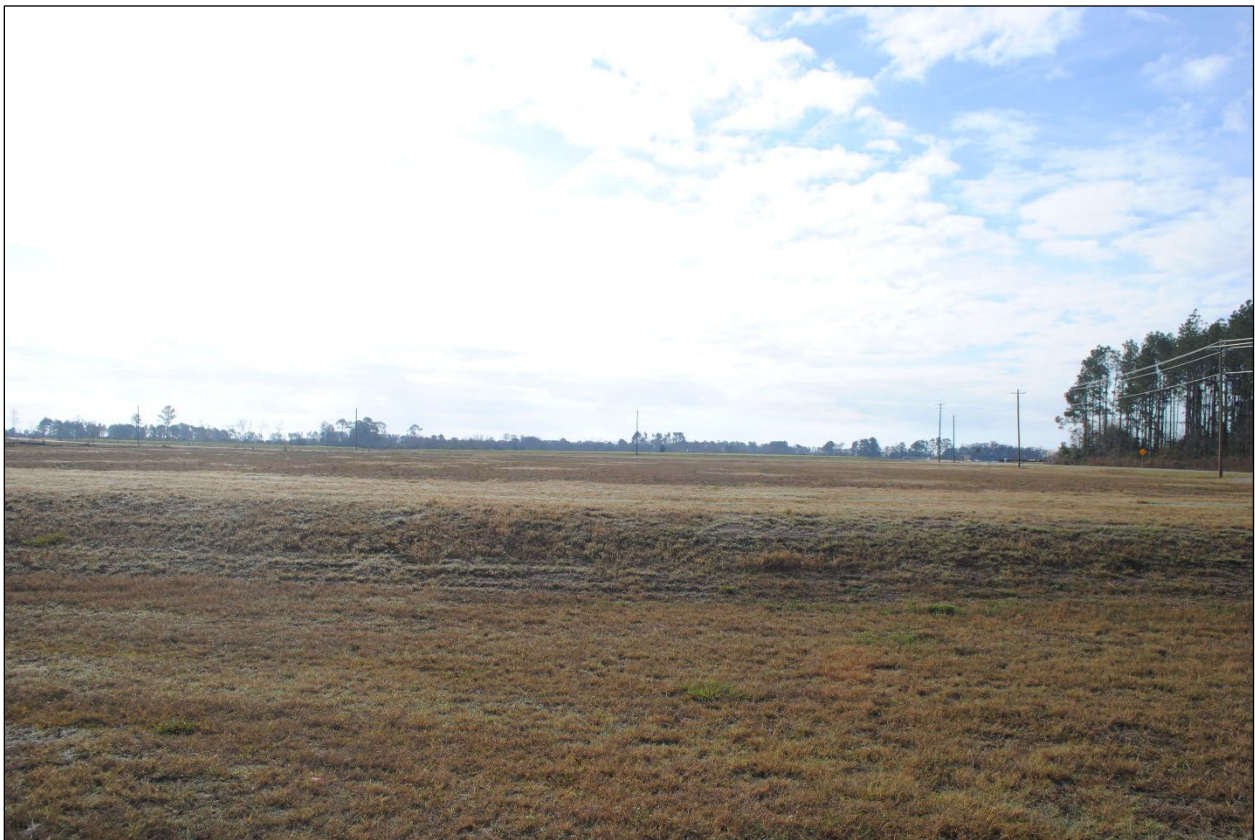
Figure 3.9 View of the disturbed filled and graded artificial terrace within the project tract, facing south.

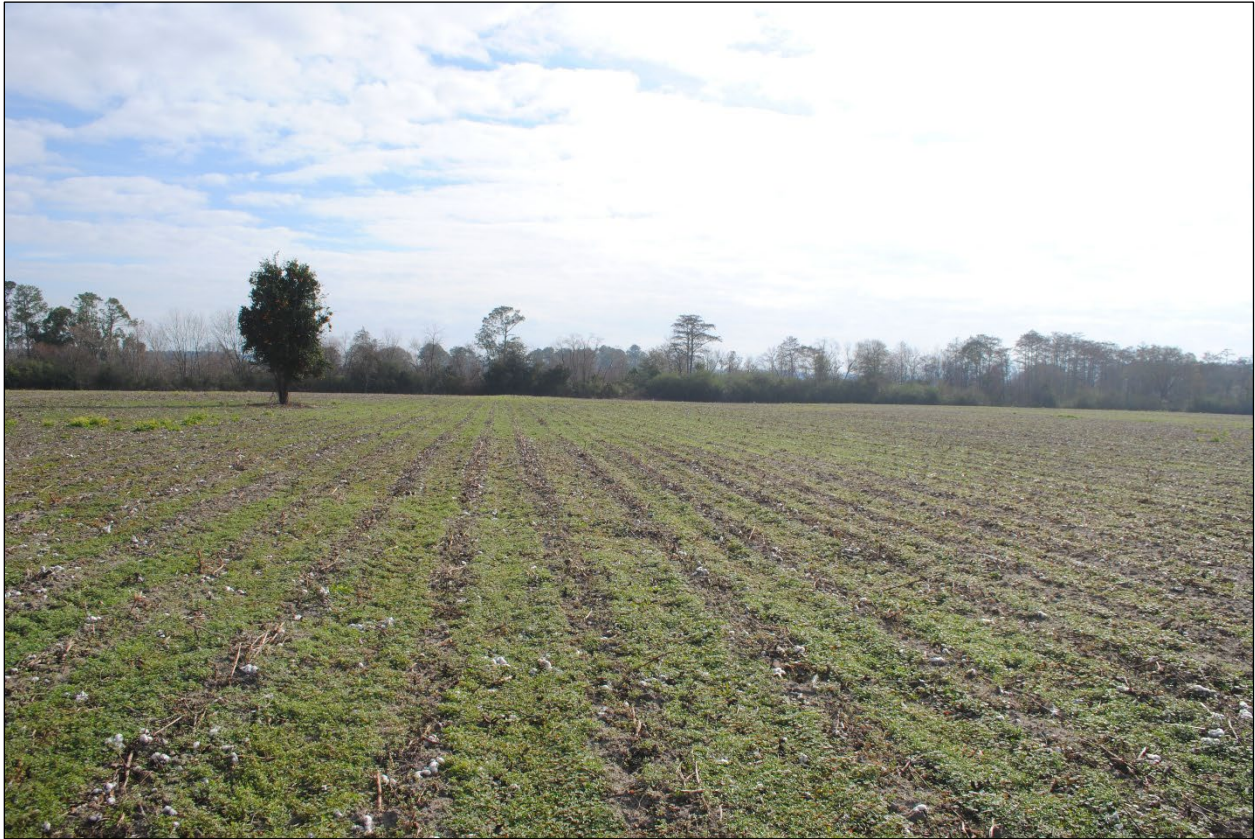
Figure 3.10 View of 9CF318, facing east.

Our field reconnaissance did not identify any new cultural resources within the project tract. We revisited the one previously recorded archaeological site (9CF318) within the project tract. All buildings and features that were observed during Sweeney and Stallings' (2017) investigation of 9CF318 have been razed and removed. Figures 3.10 and 3.11 show present views of this previously recorded site.

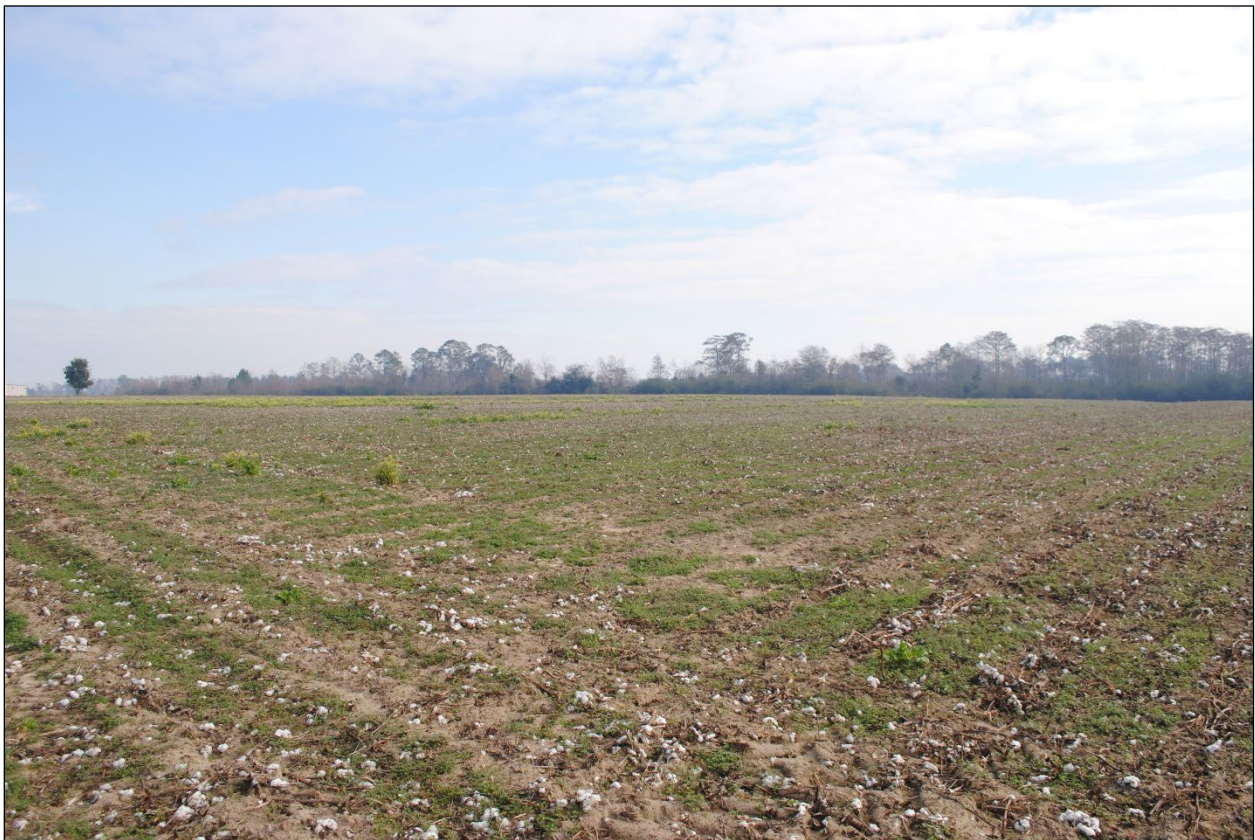
Figure 3.11 View of 9CF318, facing northeast.
